# Failure Analysis in Catheters

A client presented catheter hubs that appeared to be cracking during their manufacturing process. The hubs were compound structures with polycarbonate embedding electronics and the catheter itself. A detailed understanding the interaction between the materials and the processes in use was vital to allow determination of the cause of failure. Cambridge Polymer Group isolated the root-cause and proposed an alternative manufacturing strategy that the client adopted.

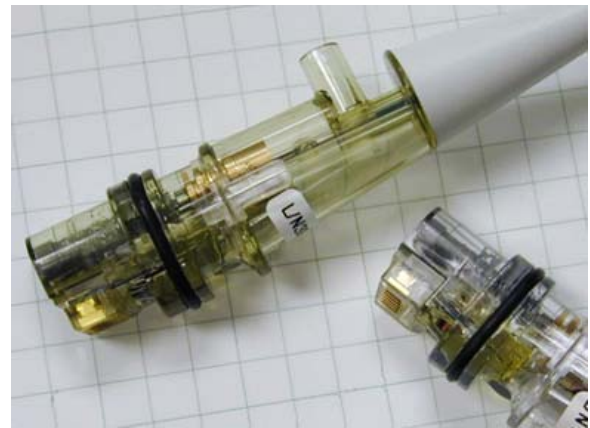
The spectacular dendritic discharge patterns formed in a dielectric by electrical discharge are known as “Lichtenberg figures” and result from breakdown of the polymer dielectric when excessive charge is built up during the high-flux electron beam radiation process. This process is analogous to the discharge that occurs during a lightning storm and can cause catastrophic failure of components if not adequately controlled. Lower energy, or non-irradiative sterilization circumvents this issue.

The client was utilizing proven sterilization technologies to provide terminal sterilization of their components. E-beam sterilization is routinely used in the biomedical industry but has a severe drawback in some materials. The high flux and beam energies cause rapid charge build up on components. If uncompensated, this charge can arc between the charged surface and metal contacts resulting in fracture of the insulating polymer. CPG determined this process as the root-cause of the issues and devised an alternative sterilization strategy utilizing the gamma radiation process allowing the client to meet their process requirements with virtually no other changes.
