Root Cause of Discolored Drug Product

By Jaimee Robertson, Director of Consulting Services

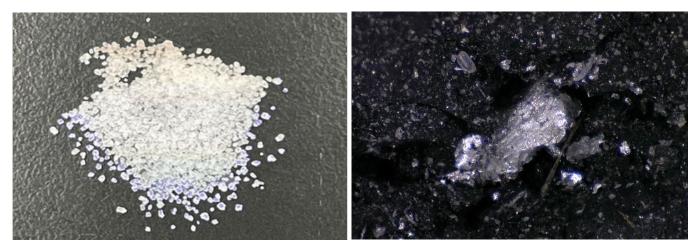
Figure 1: Left: The discoloration on the vial wall was identified as radiant particulates clustered near the rubber septum. Right: Adjacent to the particulate, the rubber septum was torn and discolored.

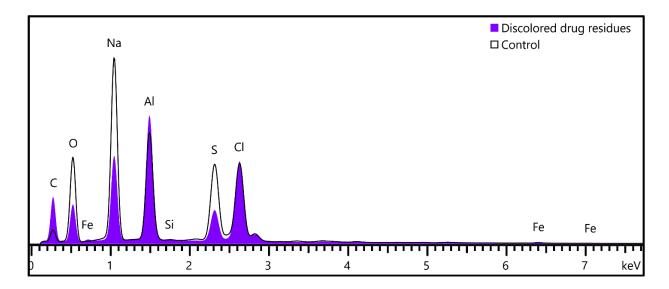
Relative to the control, the discolored drug residues had reduced sulfur, sodium, and oxygen content, all of which were associated with an antioxidant in the drug solution. Conversely, the discolored surface of the rubber septum around the embedded particle was rich in these elements. The septum surface also had elevated zinc content; as there was no zinc in the drug formulation or vial materials, the galvanized steel particle was identified as the source of the zinc. A small percentage of iron was also detected in the discolored drug residues, suggesting the presence of metallic ions from the steel particle in solution.

Figure 3: Comparison of the SEM-EDS spectra collected from the discolored drug residues and a control identified reduced sulfur, sodium, and oxygen content in the discolored residues. A small percentage of iron in the discolored residues indicated the presence of metallic ions in solution.
