# The Sulzer Recall: Process Failures & How to Find Them

By Dr. Gavin Braithwaite, Chief Executive Officer

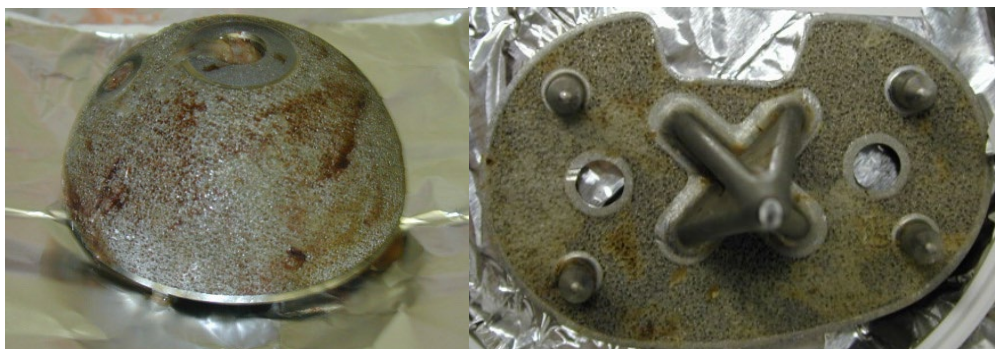
In 2000, Sulzer Orthopedics began to observe trends in the reported outcomes of some of their Interop acetabular shells. There appeared to be an evolving trend of poorly osseointegrated devices emerging after several months of implantation. The Interop shells (see Figure 1) were a relatively new design of shell using a porous titanium backing surface designed to encourage boney in-growth and therefore improved fixation in cementless surgery. Other manufacturers also possessed similar designs because of the benefits for primary surgeries, avoiding the need for the use of bone cement and simplifying revisions, if needed. Arguably the long-term

**Figure 1: Examples of explanted devices that were removed due to poor fixation.**

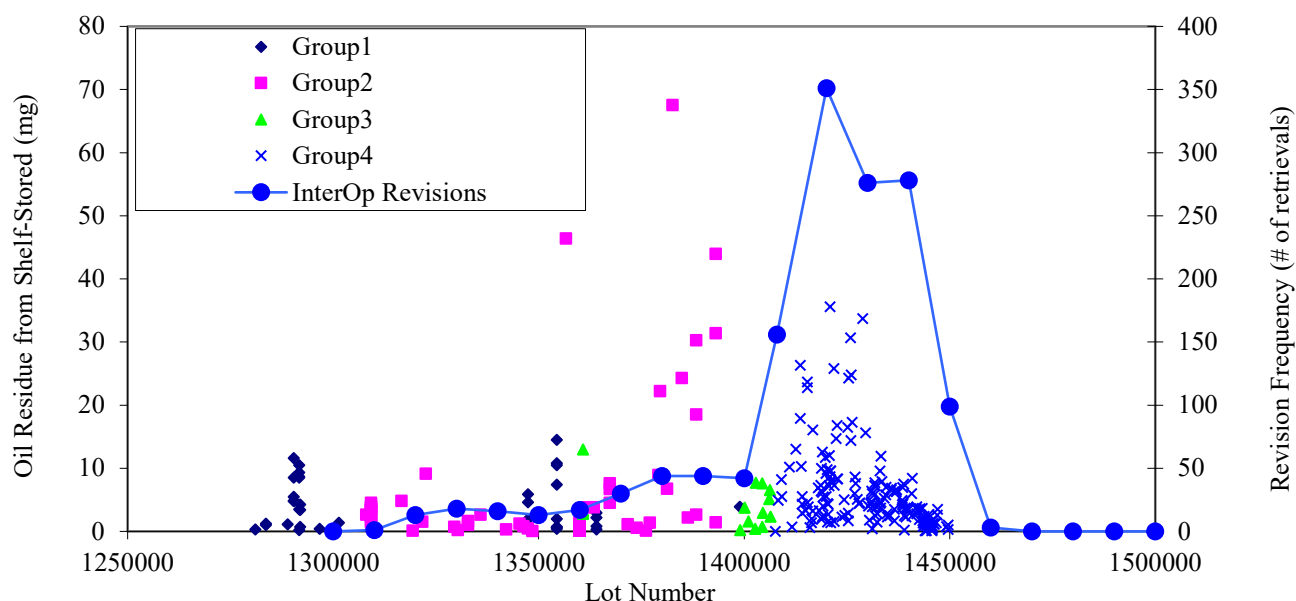
Of particular interest in the early root-cause determination was the observation that substantial machining oil was observed on the parts after explanting (Figure 2). Although the oil itself was known to be safe and had been used in lots that did not exhibit the issue, the volume of residual oil was compelling to early investigators. When Figure 2 is reviewed, the Group 4 specimens are clearly associated with an increase in the number of revisions. However, it rapidly also became clear that this could not be the entire answer since Group 2, also high in oil, did not appear to be related to revisions. Further analytical work was required.

**Figure 2: Correlation of lot number to revisions and residual oil detected.** CPG developed the data in this plot over the course of a few months, testing hundreds of shelf-stored implants.

The early hypothesis of the mineral oil alone causing the inflammation seems unlikely given that 83% of the revisions occurred in only Group 4 (Figure 2). Examination of the manufacturing process (Figure 3) seems to suggest that cleaning following manufacturing was performed in the same way. However, on closer inspection it became obvious that although cleaning was identical, one subsequent step was changed for Group 4.

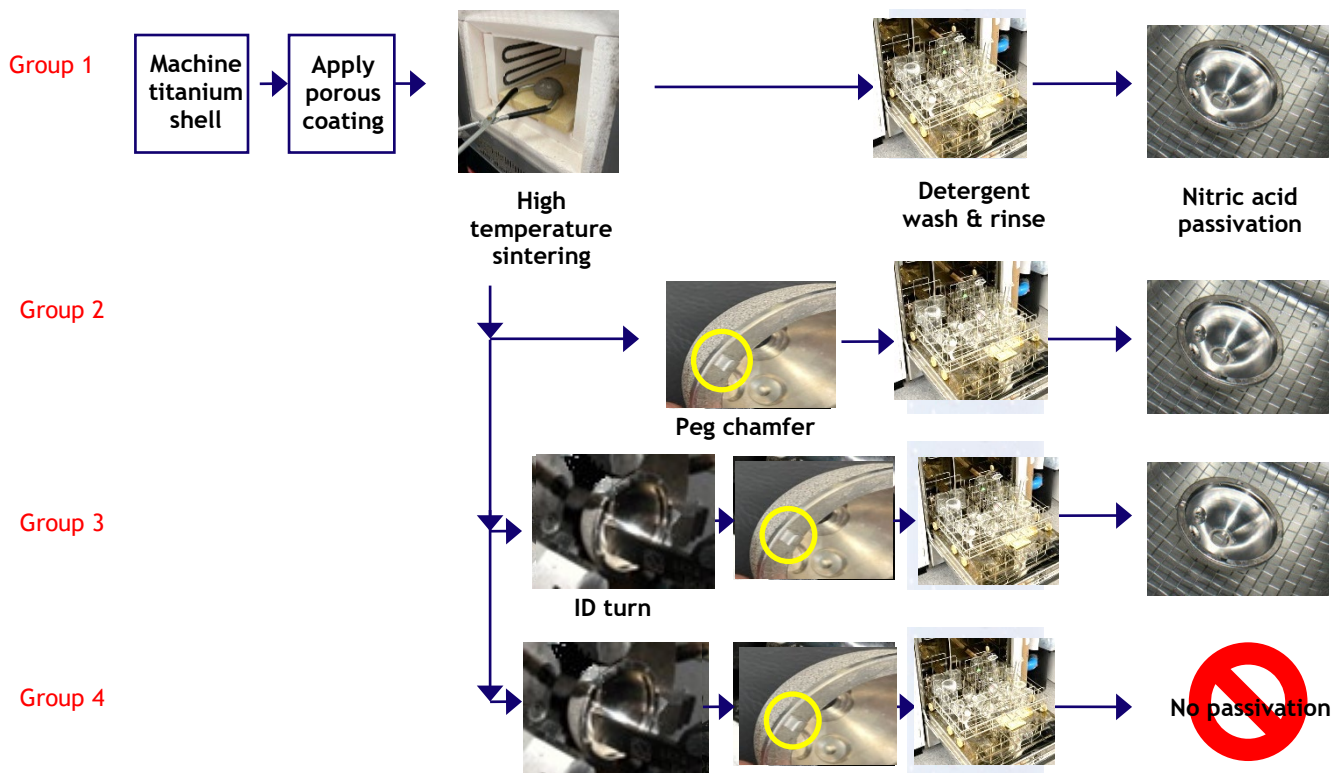
Nitric acid passivation is a common final step to help add an oxide layer to prevent corrosion and metal ion release from the metals. However, for Group 4 it was removed, reportedly because it served no functional role for cleaning and the oxide layer was not believed to be important and required additional resources and time.

Figure 3: Schematic of the manufacturing process on a group-by-group basis.

As a result of the analyses described here, Sulzer developed a new manufacturing process, which CPG helped to validate through cleanliness assessment. Although Sulzer remedied the issue and continued to successfully provide working implants to patients across the world, it never really fully recovered from the impact of the major recall associated with this issue and was eventually sold to Zimmer, Inc.
