Cracking in Polycarbonate Syringes

By Dr. Stephen Spiegelberg, Chief Scientific Officer

Summary

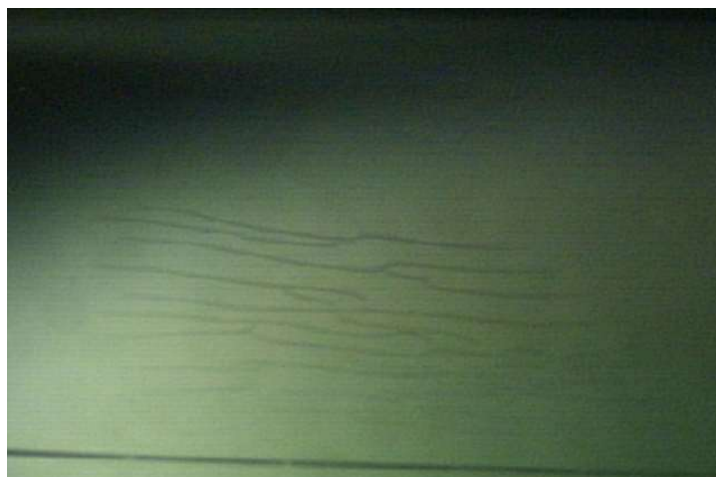
Following this information gathering step, the client provided examples of aged samples that showed cracking, as well as unaged samples with no cracking. Scanning electron microscopy (SEM) with energy dispersive spectroscopy (EDS)

Figure 1: Microcracks forming in PC syringe.

wipe) was further investigated to ensure that it did not have any undesirable effects and was eventually written into the cleaning procedure. The client also increased the cure time for the UV-curable epoxy to reduce the amount of epoxy monomer and ensured that assemblers were all wearing gloves.
