# Failure Analysis in Catheters

A client presented catheter hubs that appeared to be cracking during their manufacturing process. The hubs were compound structures with polycarbonate embedding electronics and the catheter itself. A detailed understanding the interaction between the materials and the processes in use was vital to allow determination of the cause of failure. Cambridge Polymer Group isolated the root-cause and proposed an alternative manufacturing strategy that the client adopted.

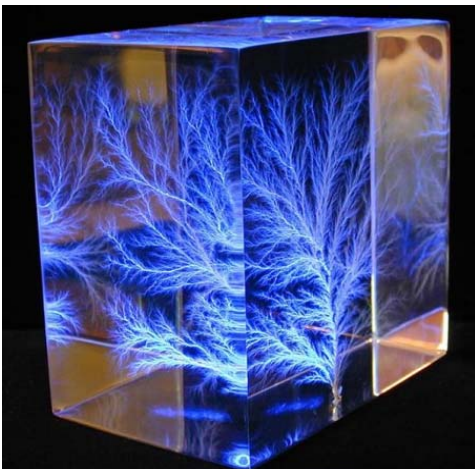
The spectacular dendritic discharge patterns formed in a dielectric by electrical discharge are known as “Lichtenberg figures” and result from breakdown of the polymer dielectric when excessive charge is built up during the high-flux electron beam radiation process. This process is analogous to the discharge that occurs during a lightning storm and can cause catastrophic failure of components if not adequately controlled. Lower energy, or non-irradiative sterilization circumvents this issue.
